PENNSYLVANIA
LEVEL II
SAMPLE RUN DAM

NDI I.D. NO: PA-00284
DER I.D. NO: 32-14

PHASE I INSPECTION REPORT
NATIONAL DAM INSPECTION PROGRAM

SAMPLE RUN DAM
NDI I.D. PA-284
NOVEMBER 30, 1979

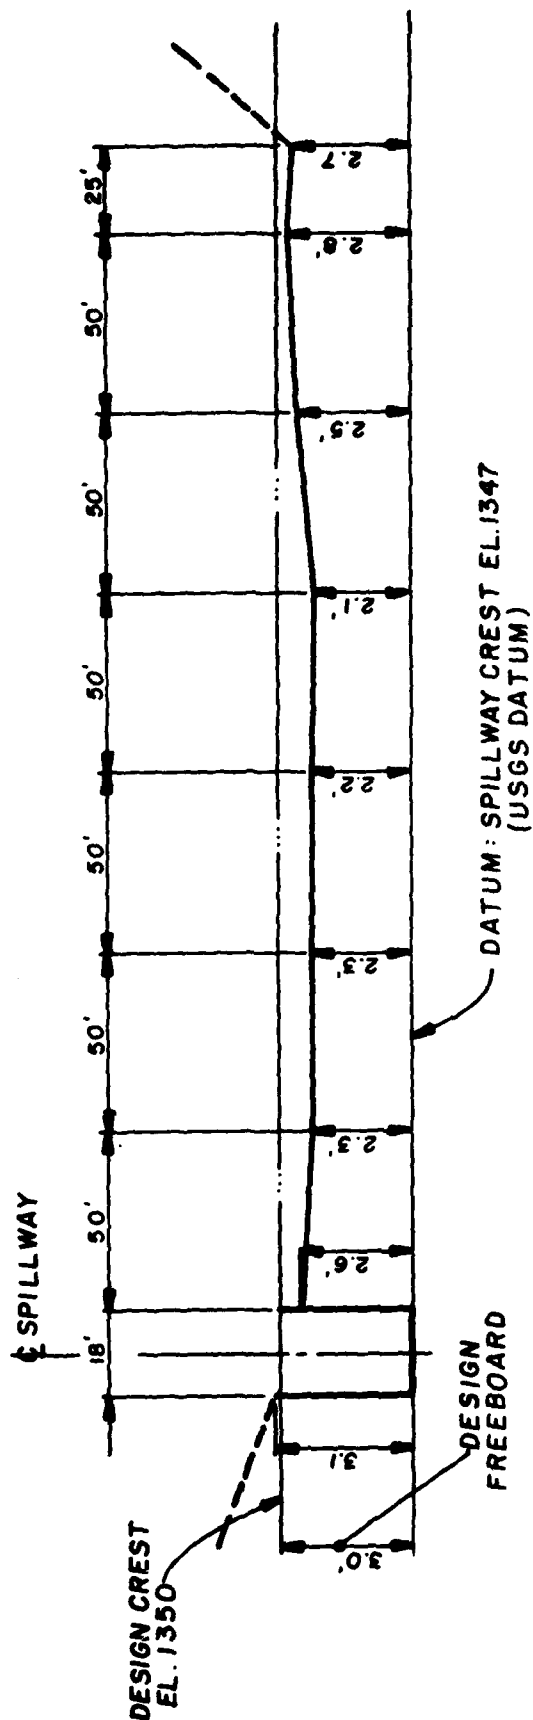
DAM CREST PROFILE (LOOKING DOWNSTREAM)

The crest of the dam was surveyed relative to the spillway crest elevation; it was found that the crest in some locations is nearly one foot below the design elevation. The dam crest profile is illustrated in Plate 7. In the transverse direction, the crest of the dam was irregular. The average crest width was estimated to be 10 feet. The downstream slope was surveyed and was found to be reasonably within the 2 horizontal to 1 vertical design slope.

a. Assessment. The visual observations indicate that Sample Run Dam is in poor condition. The dam has been abandoned and is not being maintained. The dam crest is irregular and up to about one foot below the design elevation. A portion of the downstream slope appears to be creeping. A portion of the reinforced concrete wall on the upstream side of the dam providing erosion protection has collapsed. The valve house also collapsed, burying the operating facilities under rubble. Sections of the concrete in the spillway structures are seriously deteriorated.
